PHASE I INSPECTION REPORT
NATIONAL DAM SAFETY PROGRAM

BEARPAW LAKE DAM
HILL COUNTY, MONTANA
MT - 115

Christian, Spring, Sielbach & Associates
Bozeman, Montana

Seattle District
United States
Army Corps of Engineers

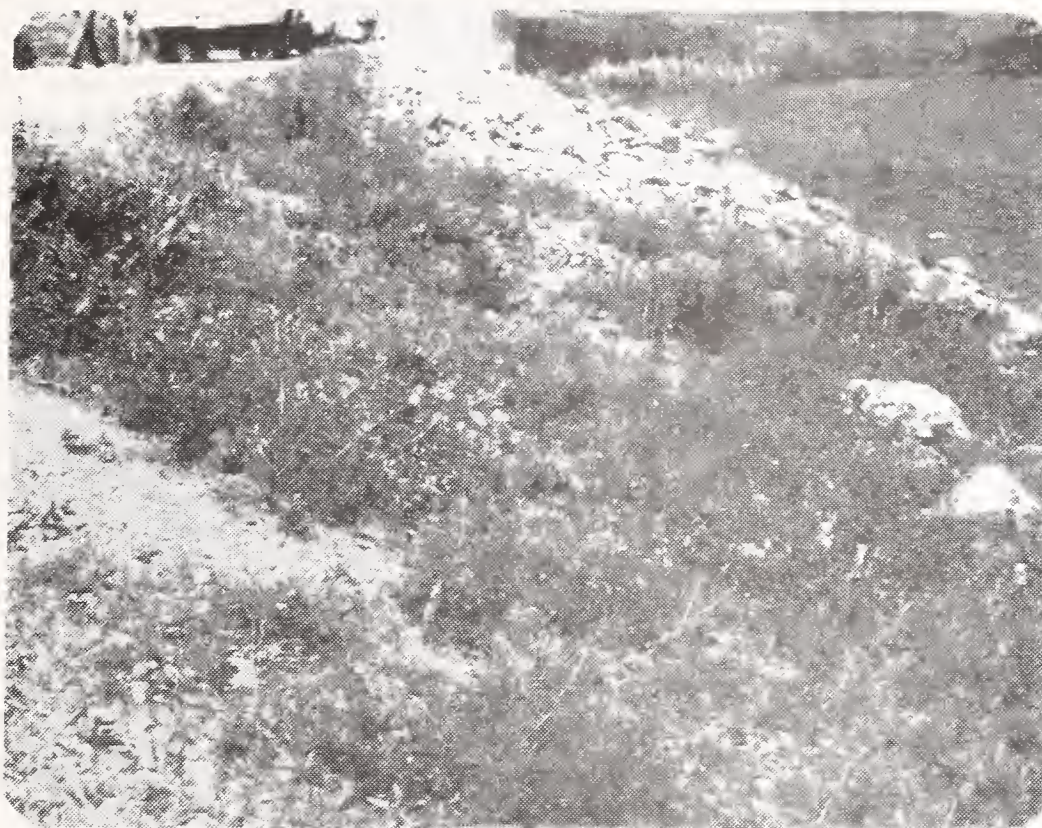
PHOTO 1 - Upstream slope Bearpaw Dam
Gate Tower top center 6/19/79

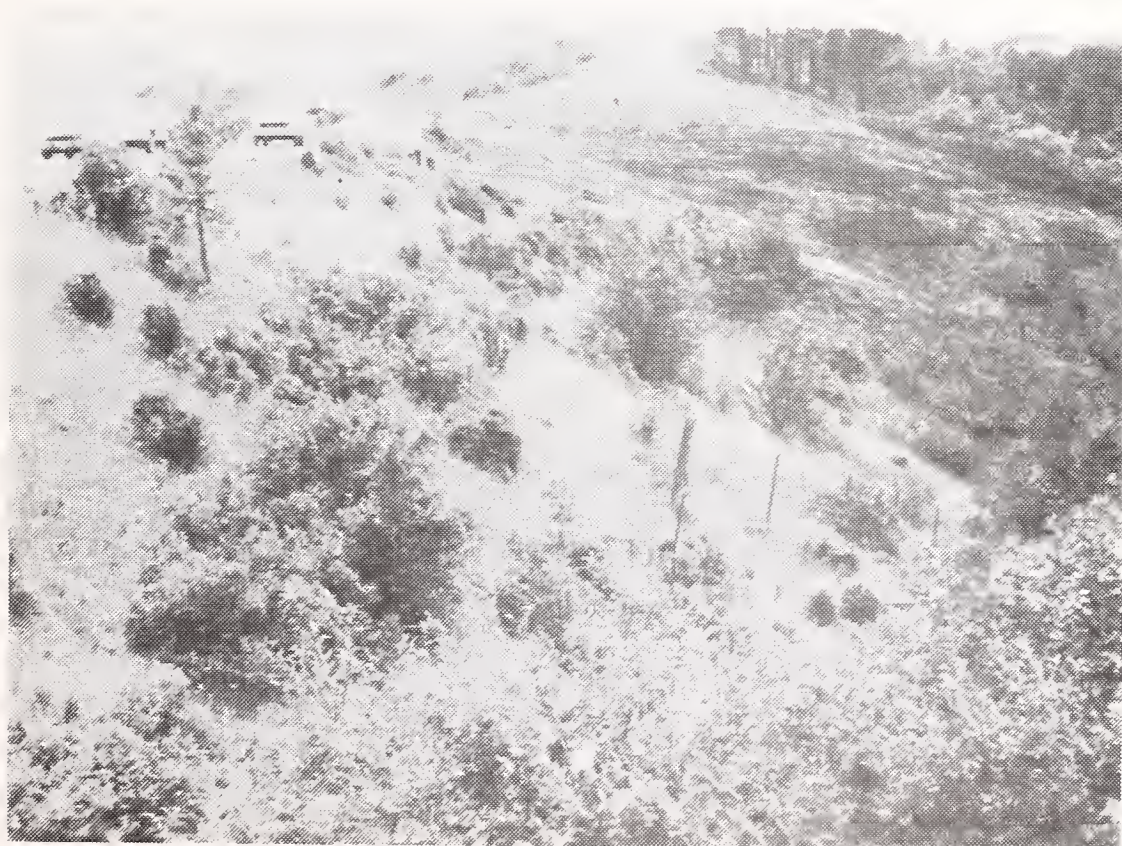
The downstream slope of the dam appeared reasonably smooth and uniform. It is covered with grass, scattered small bushes, and a few small cottonwood trees. (Photo 2) Visible near-surface downstream slope materials consist of sand and clay, with occasional cobble-size rocks. There is a small surface erosion gully on both sides of the spillway, running its entire length. This eroded area is apparently being used as a footpath. (Photos 5 and 6) There was no visible sign of unusual settlement or cracking in the dam embankment which would indicate distress. The slump near the left abutment is in natural ground rather than embankment, and does not appear to present a hazard to overall stability. The crest of the dam is used as a roadway. When wet from precipitation, it ruts and becomes very slippery. Grader maintenance may have a tendency to "wear" down the top of the dam embankment. A profile of the dam crest surveyed at the time of inspection shows reasonably uniform grade, with no severe undulations in profile (Plate 4). However, care should be exercised to maintain top of dam elevation.

PHOTO 2 - Downstream slope
Downstream left abutment 6/19/79

- 4--Repair slough on upstream face of left abutment.
- 5--Remove all trees, brush, and root systems from embankment slopes, fill voids with granular material and compact.

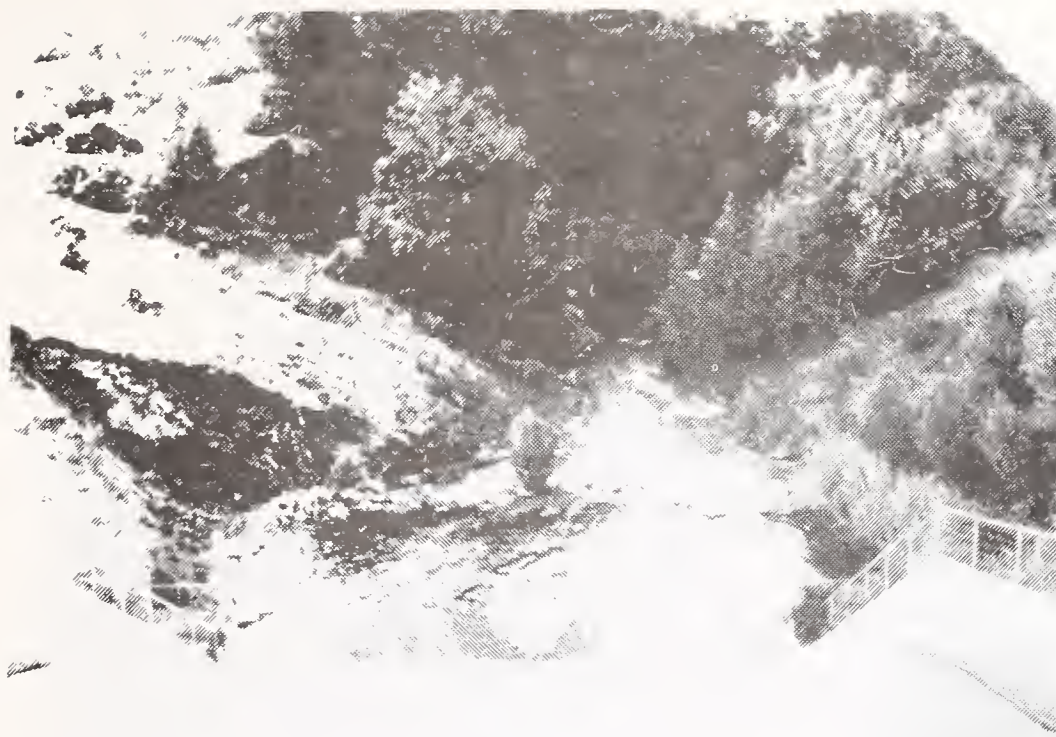
PHOTO 3 - Looking downstream; chute spillway
Note convergence of outlet channel 6/19/79

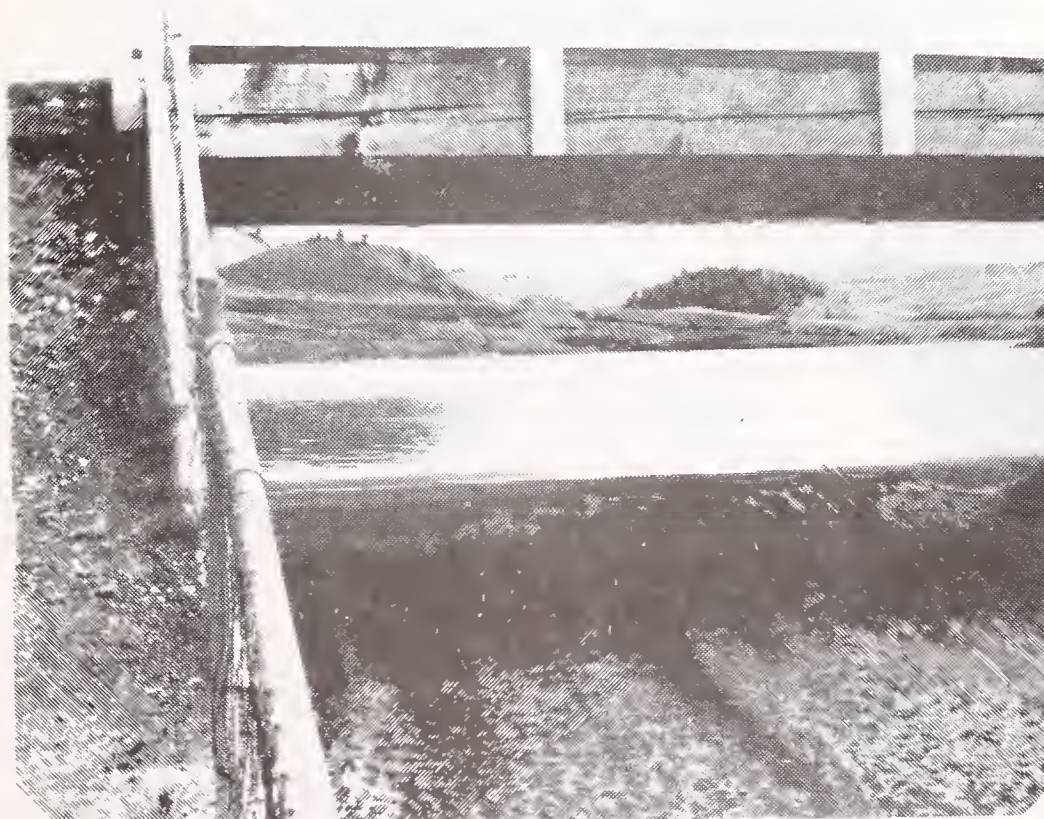
PHOTO 4 - "Ogee" crest and bridge
Flow estimated 60 C.F.S. 6/19/79

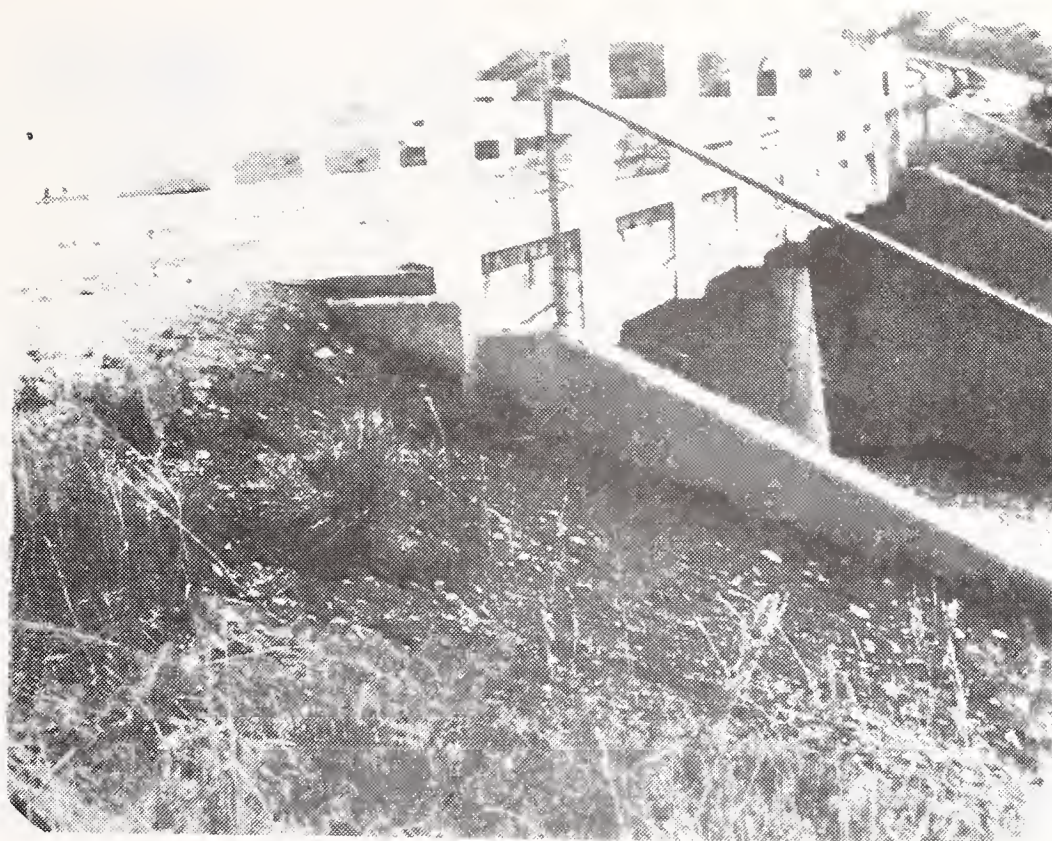
The field inspection revealed minor cracking in the chute sidewalls in a vertical direction at apparent construction joints. A shallow flow over the chute floor prevented close inspection of the floor, however, there was no evidence of serious erosion, spalling, or cavitation at the junction of sidewalls and floor. Concrete surfaces appeared hard and durable.

PHOTO 5 - Right Side Chute Spillway
6/19/79

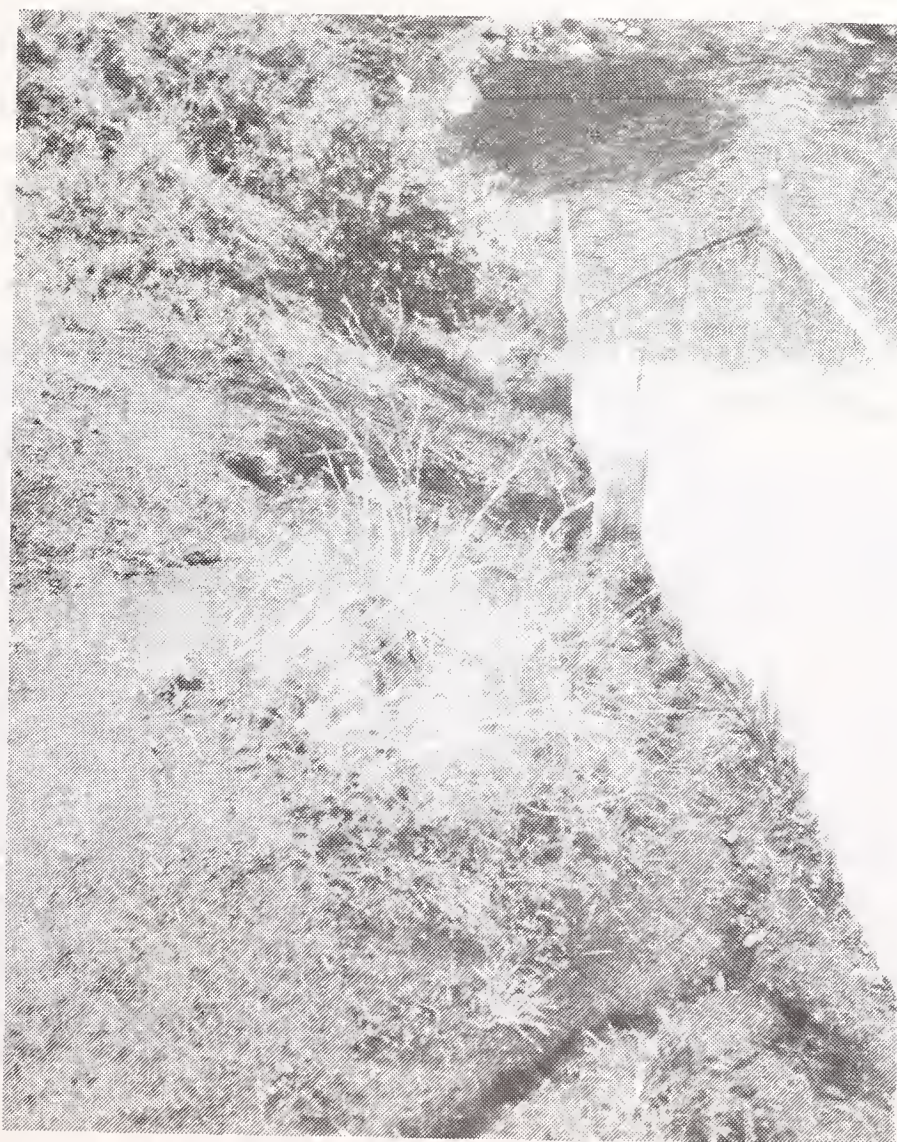
PHOTO 6 - Left Side Chute Spillway
6/19/79

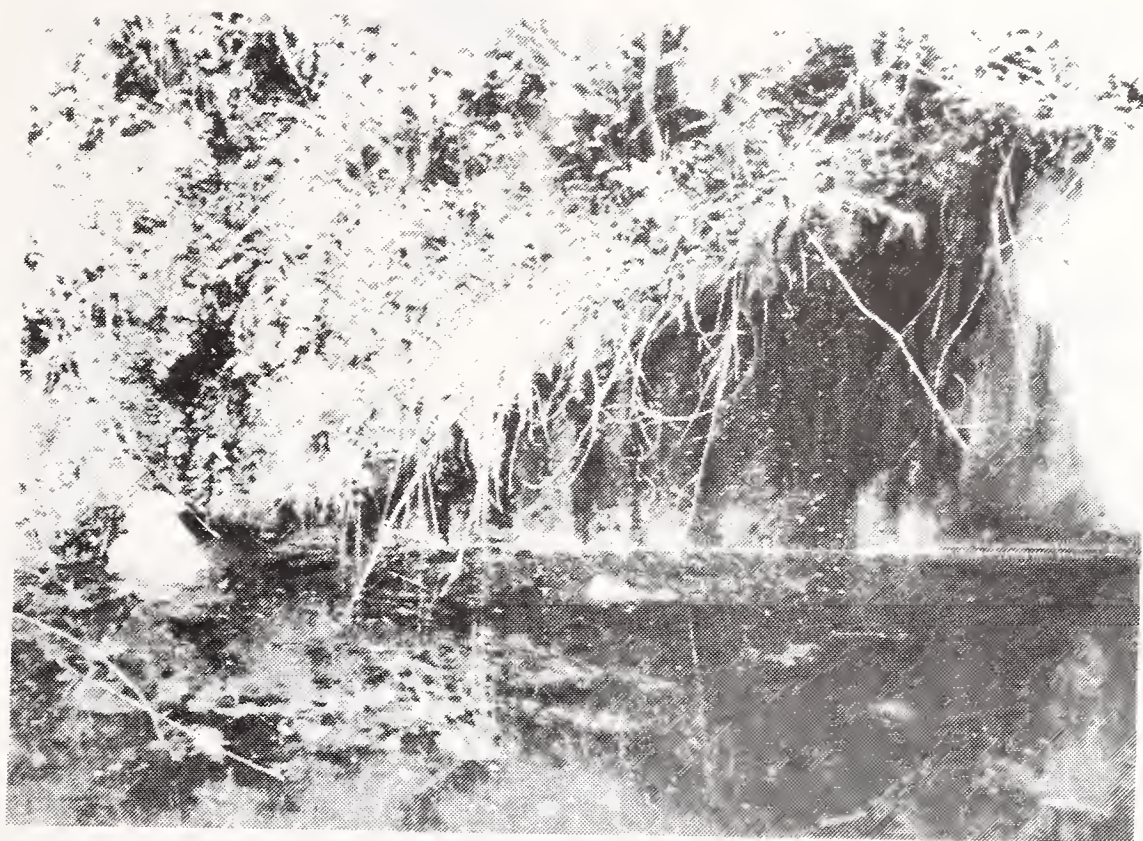
At the downstream toe a small seepage area was noted just above the conduit outlet. (Photo 7) Further investigation revealed that this seepage area is the exit point for an 8-inch concrete drain pipe, shown on the "as-built" plans. The drain pipe follows the trough of the downstream toe from the right abutment and terminates just above the conduit outlet. The drain was installed at the time of construction, and reportedly drains a

small spring that existed before construction. A small trickle was observed flowing from the pipe. Tree roots may be clogging the drain line.

PHOTO 7 - Just downstream from conduit outlet
showing seepage (dark line area left side photo)
outlet for 8" diameter drain

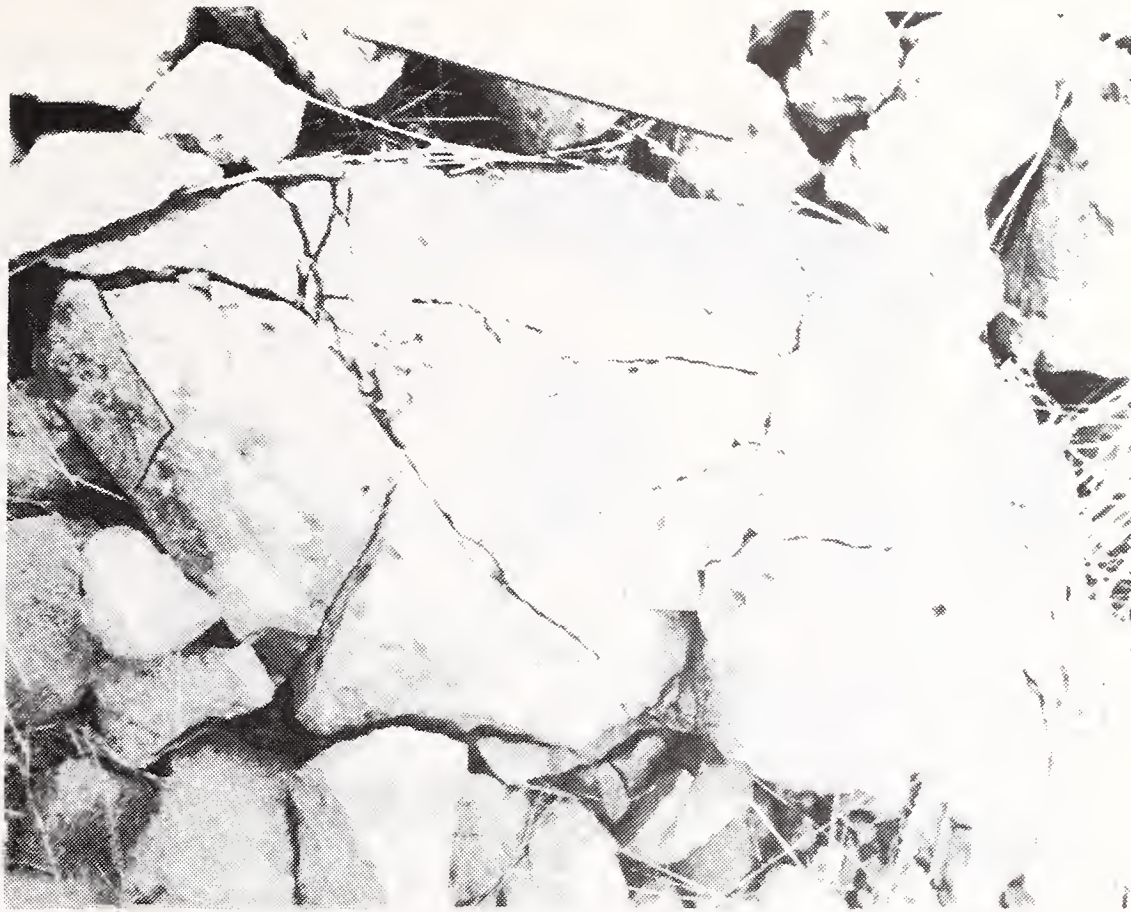
The field inspection showed that riprap on the upstream slope consists of gravel to boulder size volcanic agglomerate. The riprap is in poor condition due to weathering action, with many of the cobbles and boulders broken down. (Photo 9) Large areas (two to three square yards) consist only of gravel size agglomerate fragments. Although riprap was originally placed to the crest of the dam, portions have been dragged below pool level, possibly by ice action. (Photo 1) This is particularly apparent near the spillway, where a section of riprap has been dragged below normal pool level giving the impression of a slump. Closer inspection revealed there is no slump. A small slump was noted in natural ground near the left abutment on the upstream slope of the reservoir. (See Photos 10 and 11 and Plate 3) Reportedly, the slump resulted when new riprap was placed in this area. The added weight apparently exceeded the shear strength of the underlying saturated soil mantle, with consequent slope failure. The slump appears to be localized and is backed by a thick section of the abutment.

PHOTO 9 - Freeze thaw breakdown of riprap

- 2--Inspect the outlet conduit in its entirety. Repair as required.
- 3--Provide upstream slope protection by upgrading rock quality and replacing riprap.

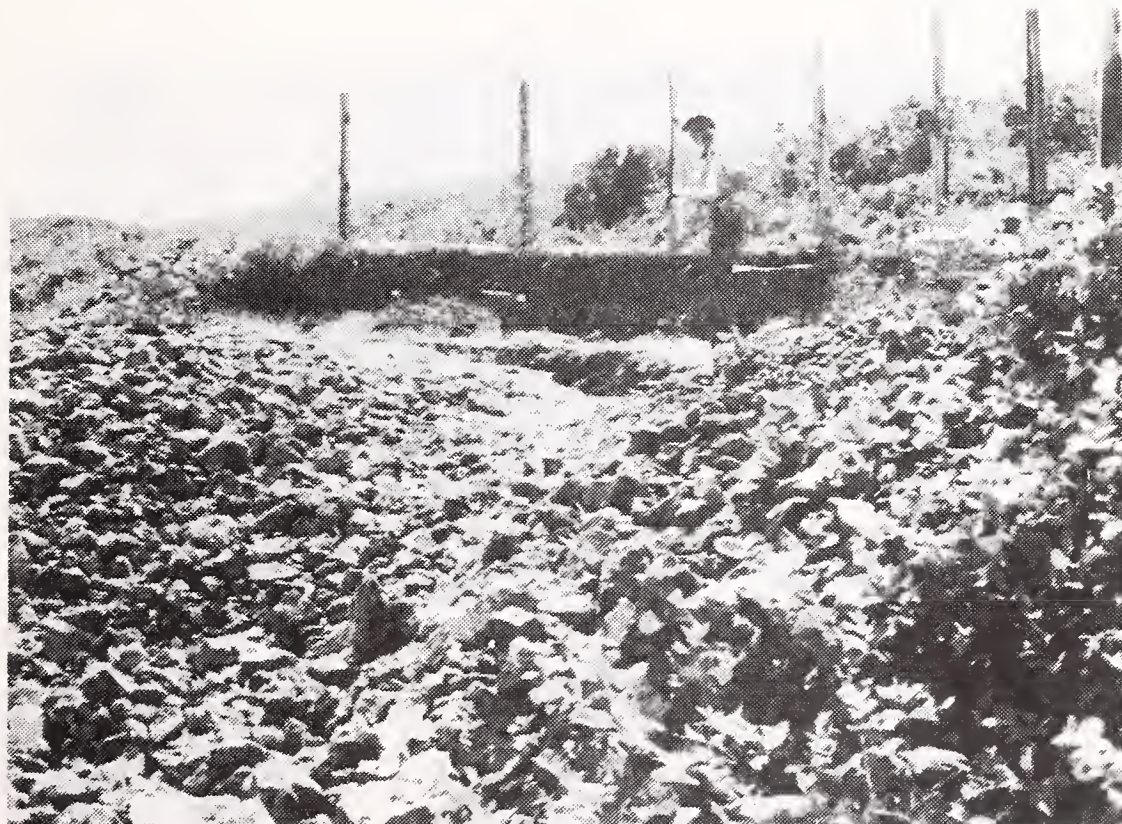
A small slump was noted on natural ground upstream from the left abutment, and near the shoulder of the road. The slump has apparently resulted from added weight of new riprap placed in this area. The slump is away from the dam embankment and is backed by a thick section of the rock abutment. It does not endanger dam stability, however, repairs need to be made to protect the shoulder of the road.

PHOTO 10 - Slump upstream left
(east) abutment

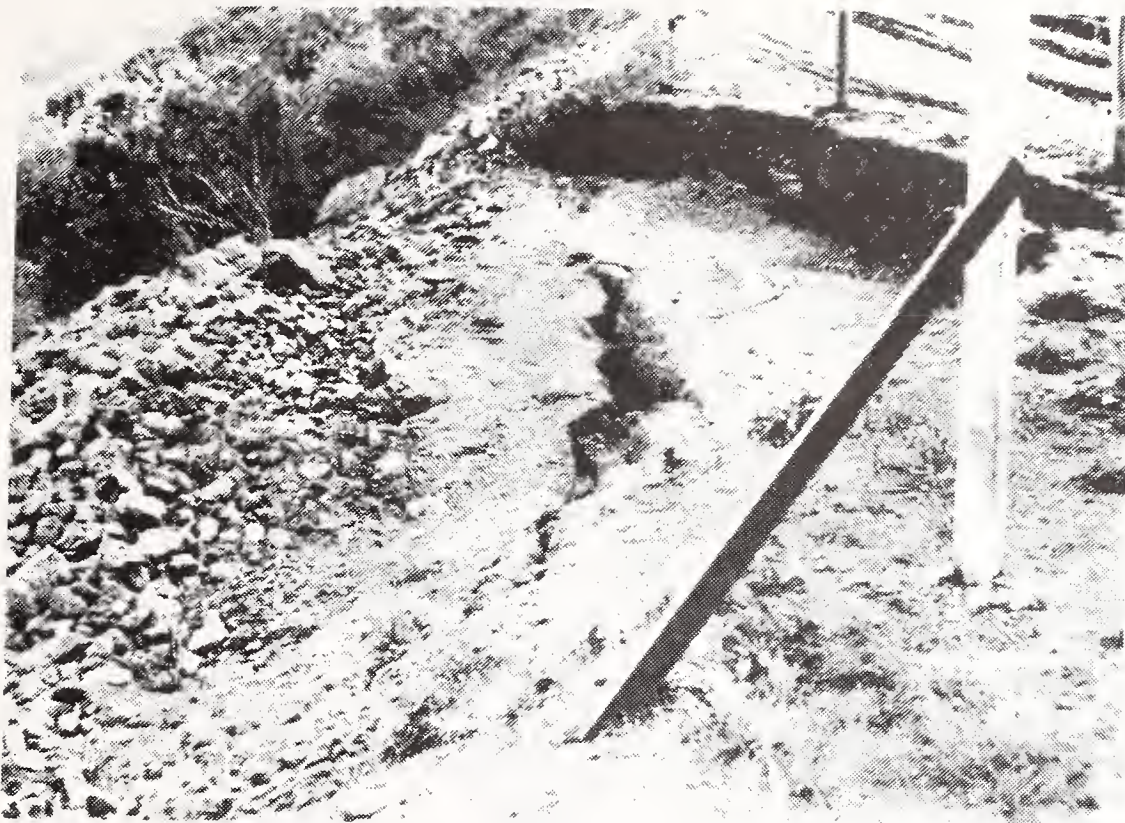
PHOTO 11 - Closer view slump
upstream left abutment

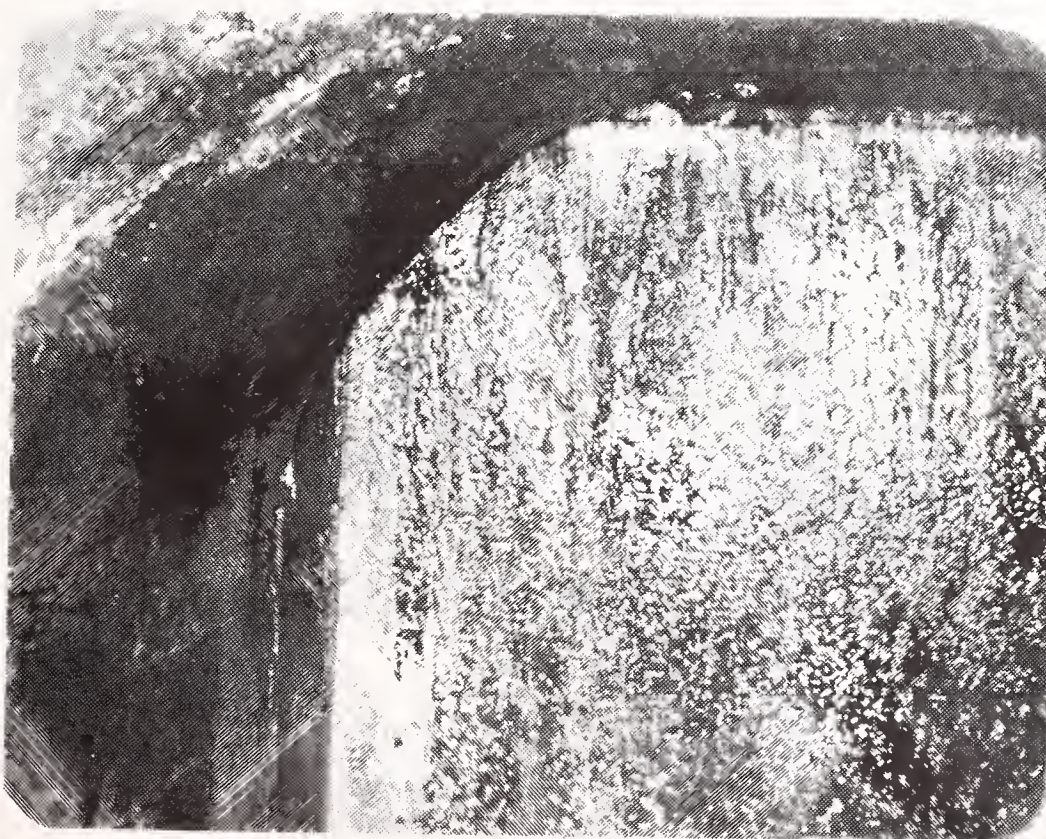
The valve tower and gates appear in good condition. The upstream or guardian gate leaked at top and bottom when fully closed. One lift crank was broken. The large amount of organic sediments at the bottom of the gate well and algae on the gate stems indicated that the gates had not been operated in some time.

PHOTO 12 - Downstream side of 36" x 36"
Armco 50-10 Slide Gate

- 6--Operate gates on outlet works through their full range of operation at least twice annually. Replace broken lift crank.
- 7--Repair and maintain the dam crest at or slightly above design elevation.

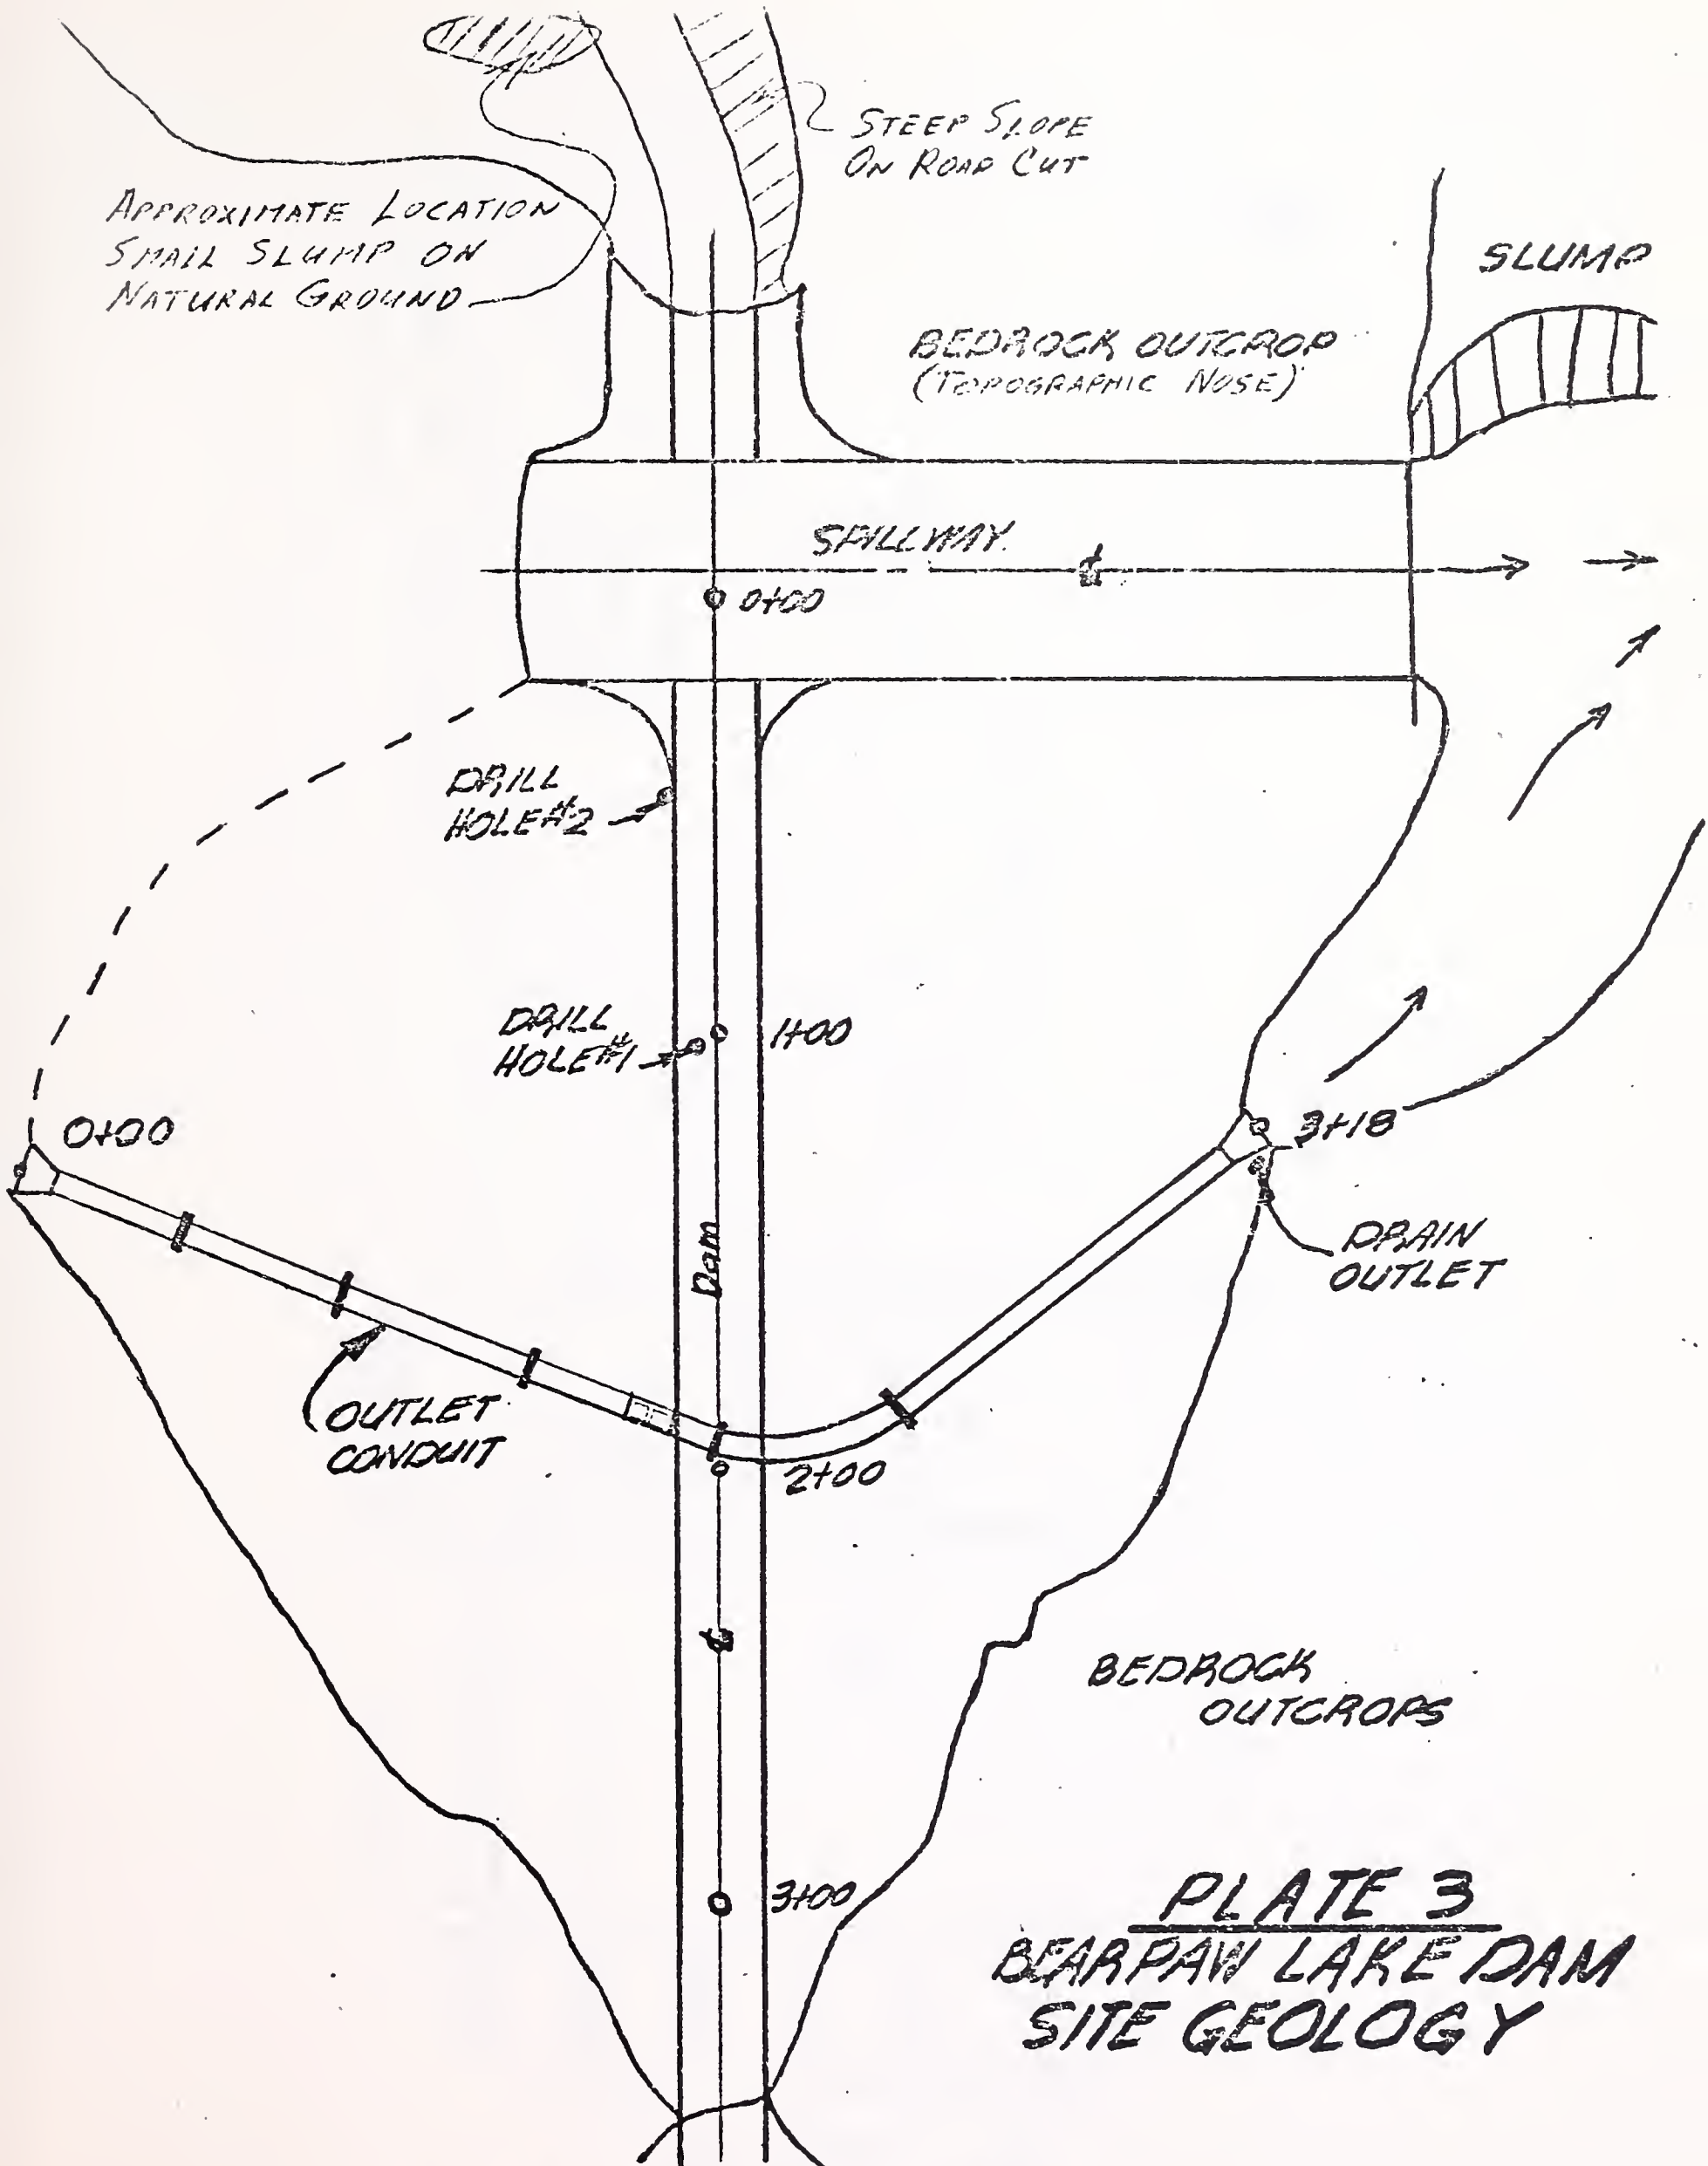
SITE PLAN OF DAM

APPROXIMATE LOCATION
SMALL SLUMP ON
NATURAL GROUND
